Manhole Inspection Summary

Manhole # S27C__017MH

Insp Date: **11/29/07 3:12 PM**

Location Address: **321 POPPLETON ST**

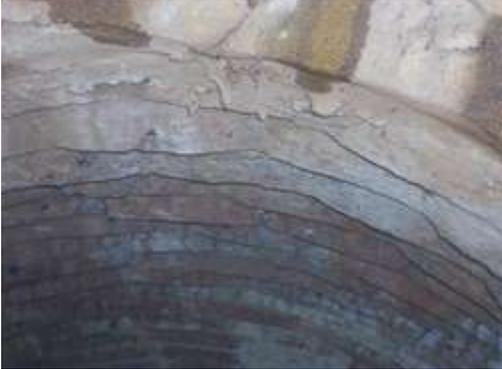
Defect 2

Condition: Sound Cracked Root Intrusion Loose Brick **Deteriorated**

DETERIORATED BARREL

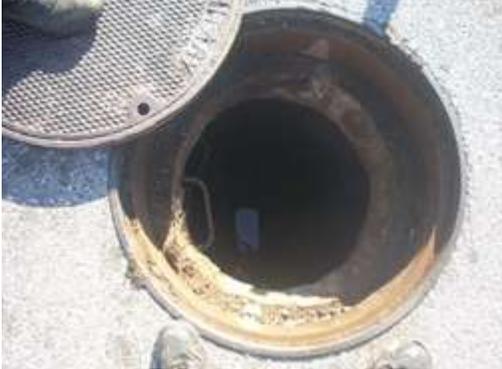
Defect 1

Comments **frame looks too wide for mh - 11-27-07**

FRAME SEEMS WIDER THAN MH LID

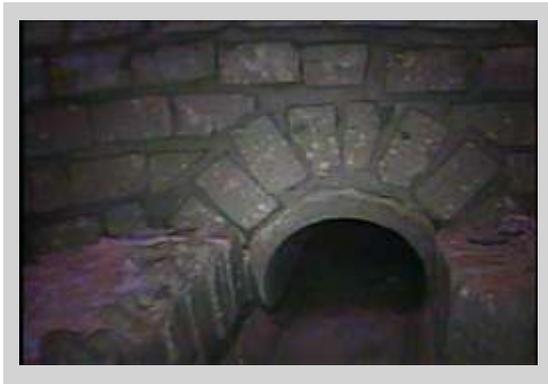
12 O'Clock Outflow

Pipe Height: **8.4** (in.) Rod and Bar (Angled)
Pipe Material: **Clay** Pipe Lined
Invert Depth: **11.14** (ft.) Flow Characteristics: **Slow**
Deposits: None Mud ~~Gravy~~ Debris Grease
Silt Depth: (in.) Deposits Extent:
Infiltration: **None** Pipe Seal Cond: **Sound**

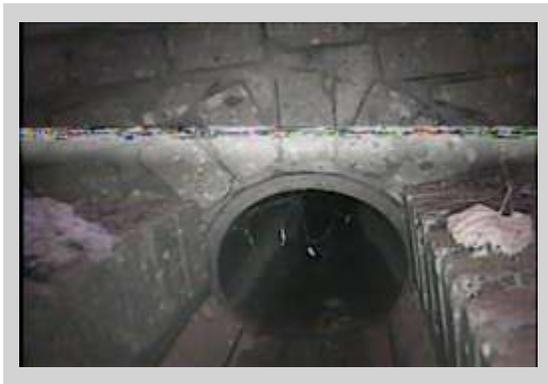
3 O'Clock Inflow

Pipe Height: **8.4** (in.) Rod and Bar (Angled)
Pipe Material: **Clay** Pipe Lined
Invert Depth: **11.01** (ft.) Flow Characteristics: **Slow**
Deposits: None Mud ~~Gravy~~ Debris Grease
Silt Depth: (in.) Deposits Extent:
Infiltration: **None** Pipe Seal Cond: **Sound**

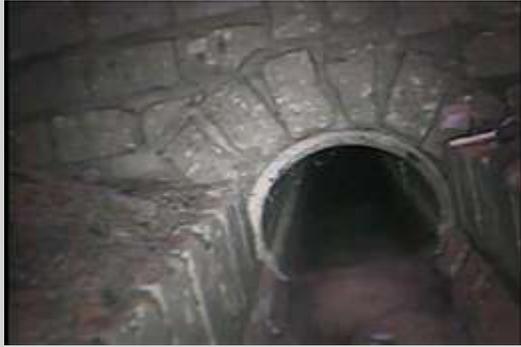
6 O'Clock Inflow

Pipe Height: **8.4** (in.) Rod and Bar (Angled)
Pipe Material: **Clay** Pipe Lined
Invert Depth: **11.09** (ft.) Flow Characteristics: **Slow**
Deposits: None Mud **Sludge** Debris Grease
Silt Depth: **1** (in.) Deposits Extent: **Light**
Infiltration: **None** Pipe Seal Cond: **Sound**

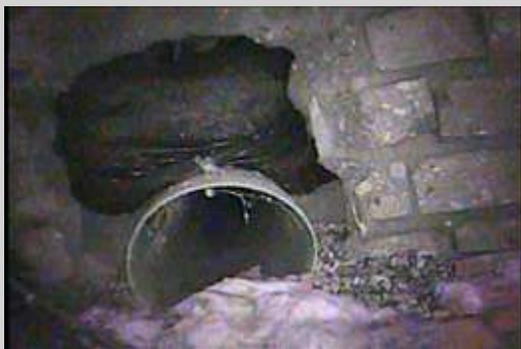
9 O'Clock Inflow

BARREL DETERIORATION

Pipe Height: **6** (in.) Rod and Bar (Angled)
Pipe Material: **PVC** Pipe Lined
Invert Depth: **10.50** (ft.) Flow Characteristics: **None**
Deposits: None Mud **Sludge** Debris Grease
Silt Depth: **3** (in.) Deposits Extent: **Medium**
Infiltration: **None** Pipe Seal Cond: **Broken**
